Initial House Assessments & Sealing Options:

July 2017

Dave Bohac, PE
Center for Energy and Environment

Ed VonThoma
Building Knowledge

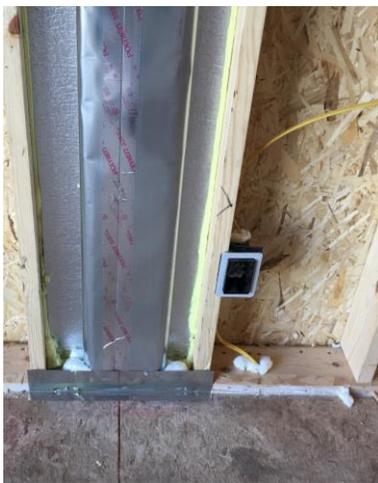
Duct and electric penetration thru exterior wall base plate

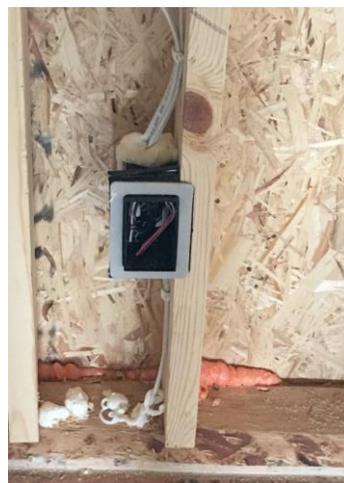
Air-tight electric box at exterior wall; caulk base plate/floor joint

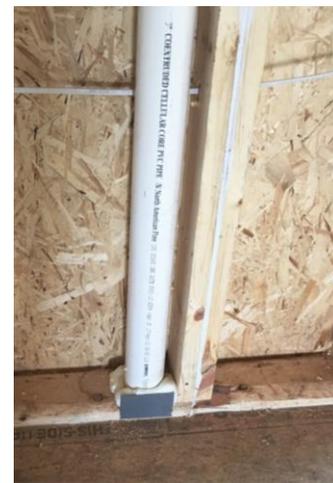
Plumbing penetration and caulk gap between studs

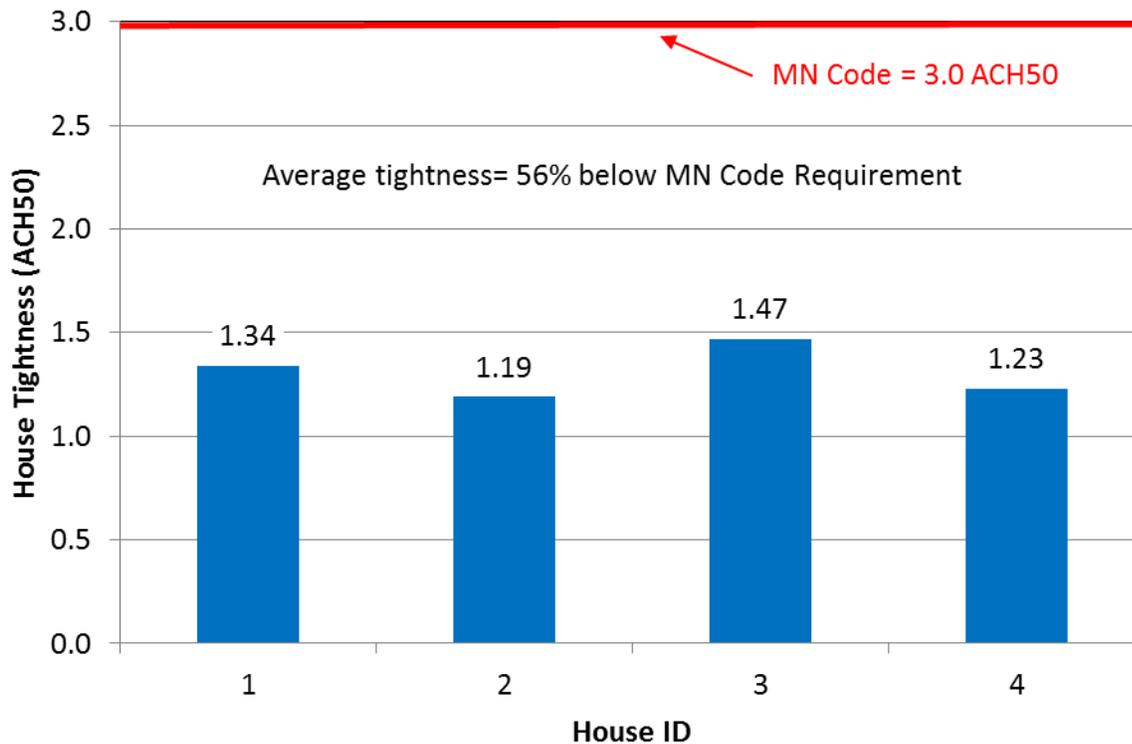
Figure 2. House tightness test results from four HERS rater reports

The HERS rater reports indicated consistently tight houses with quality air sealing practices. We reviewed HERS rater reports on four houses to evaluate the typical air leakage achieved and any common air leakage issues for recently completed houses. The HERS rater reports indicated consistently tight houses with quality air sealing practices. The reports were conducted for houses with a floor area of 3,647 square feet located in Cottage Grove, Minnesota (3 houses) and Lakeville, Minnesota (1 house). The inspections were conducted from August 17, 2016, to March 7, 2017. As shown in Figure 2 below, the air leakage test results ranged from 1.19 to 1.47 ACH50, which is 51% to 60% below the State of Minnesota code requirement of 3.0 ACH50.

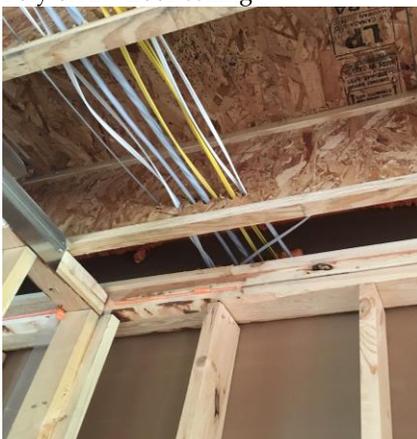
Foam seal electrical penetrations to garage

Spray foam was used to seal multiple gaps between the first floor living space and garage prior to the AeroBarrier sealing. These included large ($> 3/8"$) gaps around electrical penetrations, duct penetrations, and near ceiling joists.

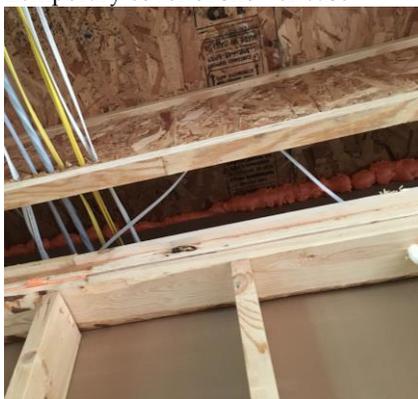
Foam seal gap at top of garage drywall

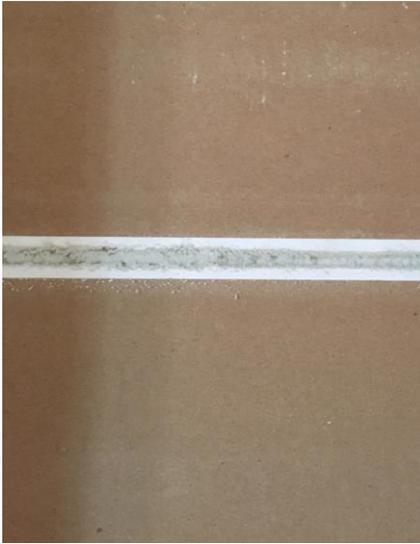
Gap between drywall sheets

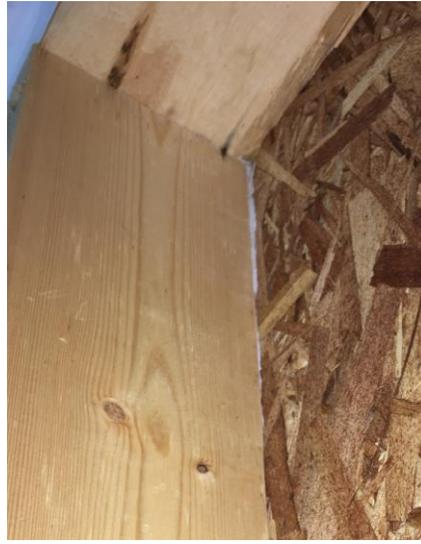
Gap between framing and sheathing

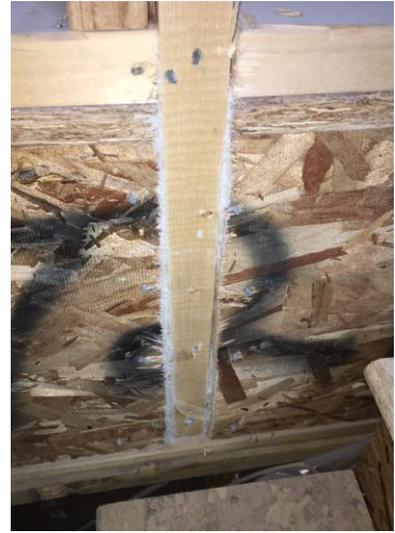
Rim joist gaps

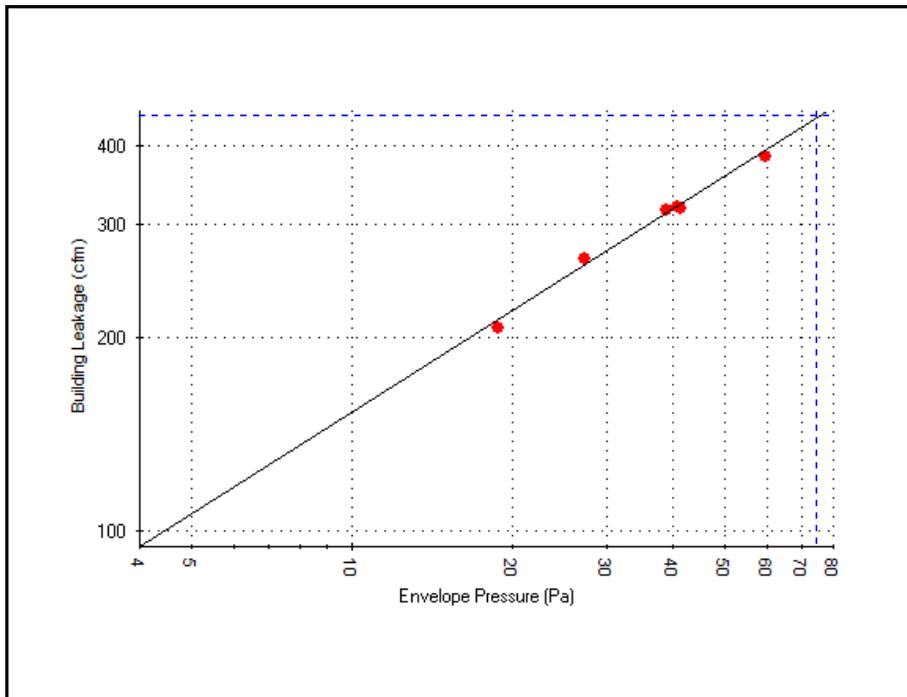
Figure 7. Post-sealing house leakage measurements

A multi-point house leakage measurement at the end of the AeroBarrier sealing resulted in a tightness of 358 cfm₅₀ or 0.64 ACH₅₀ (see Figure 7). The reduction of 84% is consistent with the reductions obtained for previous projects. This is 79% below the State of Minnesota code requirement of 3.0 ACH₅₀. It is also 51% less than the average house tightness of 1.31 ACH₅₀ for the four completed HERS rated houses and only 7% higher than the Passivhaus standard of 0.6 ACH₅₀. This very tight construction was achieved without the poly vapor/air barrier in place on the walls and without the spray foam insulation/air sealing of the rim joists. This suggests that the current level of house tightness of 1.3 ACH₅₀ could be produced without much of the current air sealing when AeroBarrier sealing is applied.
